Microscopical Examination of Paint samples Cleaning Hempel Silylated Acrylic Anti-fouling

Report : Peter Sorensen

Report date: 10.09.2014

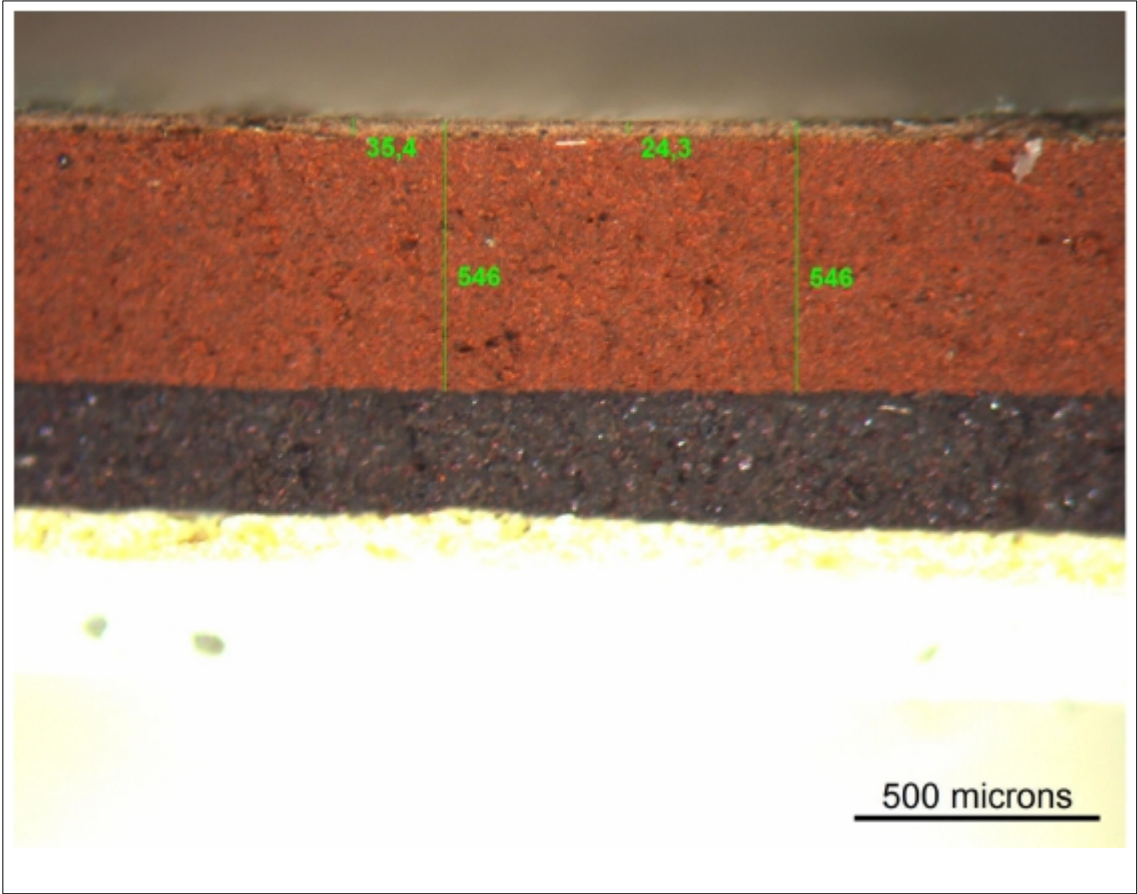
Sample	Total anti-fouling layer	Leached layer
Before cleaning	Average 546 mic. (546 mic. and 546 mic.)	Average 29,85 mic. (35,4 mic. and 24,3 mic.)
After first sweep	Average 510 mic. (510 mic. and 510 mic.)	Average 25,4 mic. (26,5 mic. and 24,3 mic.)
After 60 sec. in same pos.	534 mic.	No remaining leached layer

Before cleaning

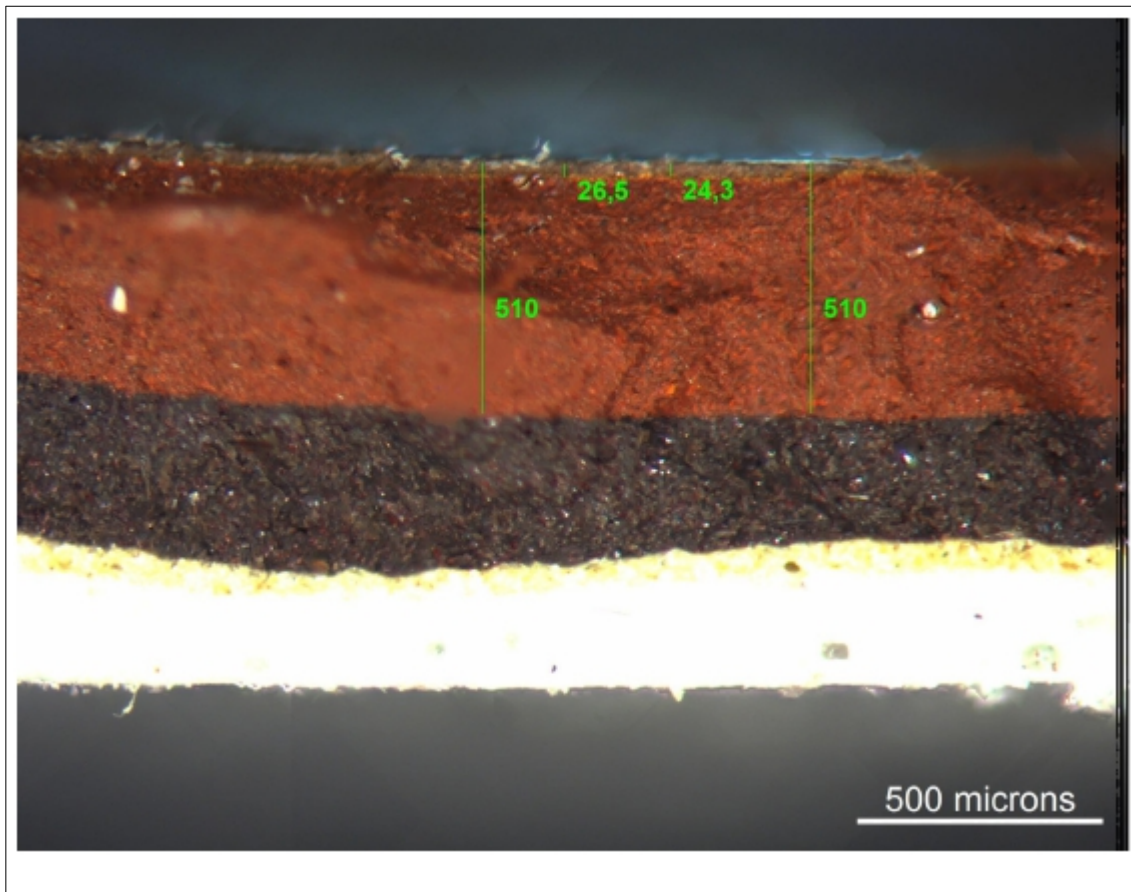
After first sweep

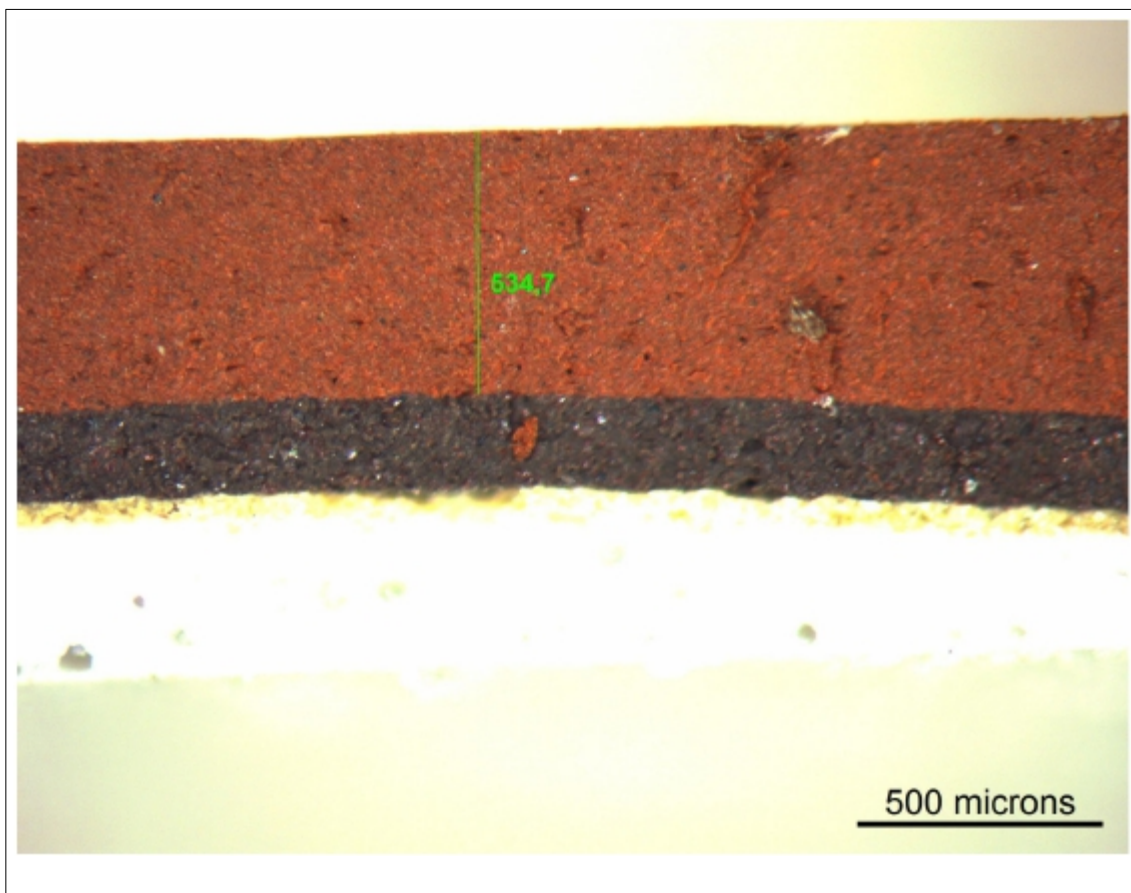
After 60 seconds in same position.
